NOVEMBER 13, 2023

RE: POST-FIRE EVALUATION: SUPPLEMENTAL LETTER: COLLINS RESIDENCE, VFES OK-04.28.2021.01: 1312 WEST 60TH STREET NORTH, MUSKOGEE, OKLAHOMA:

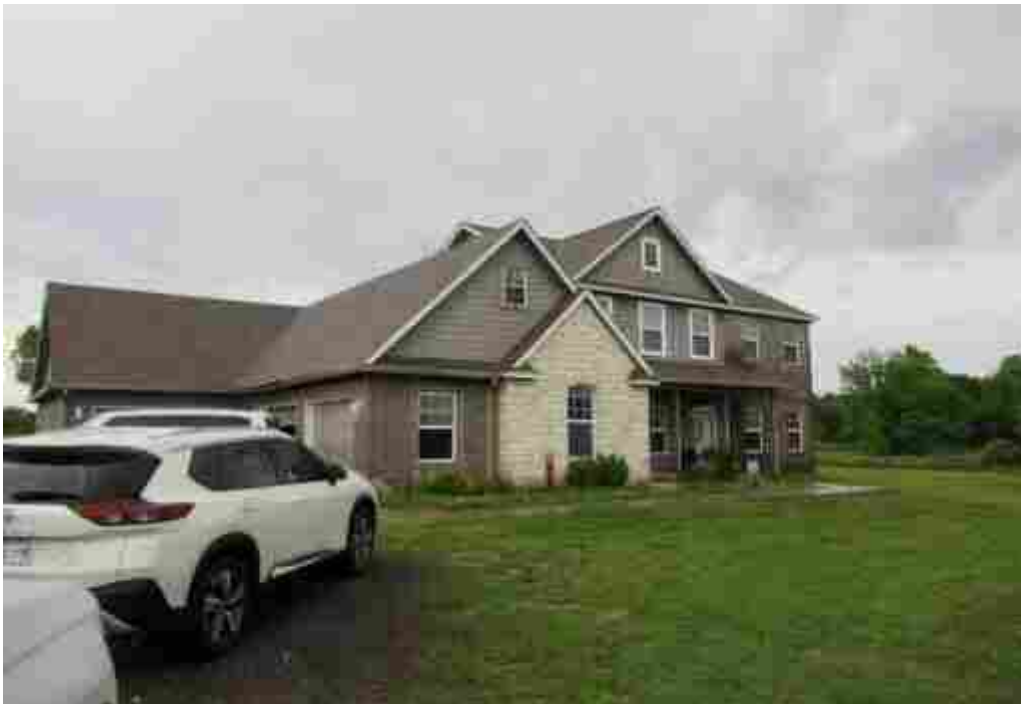
Front of the subject residence.

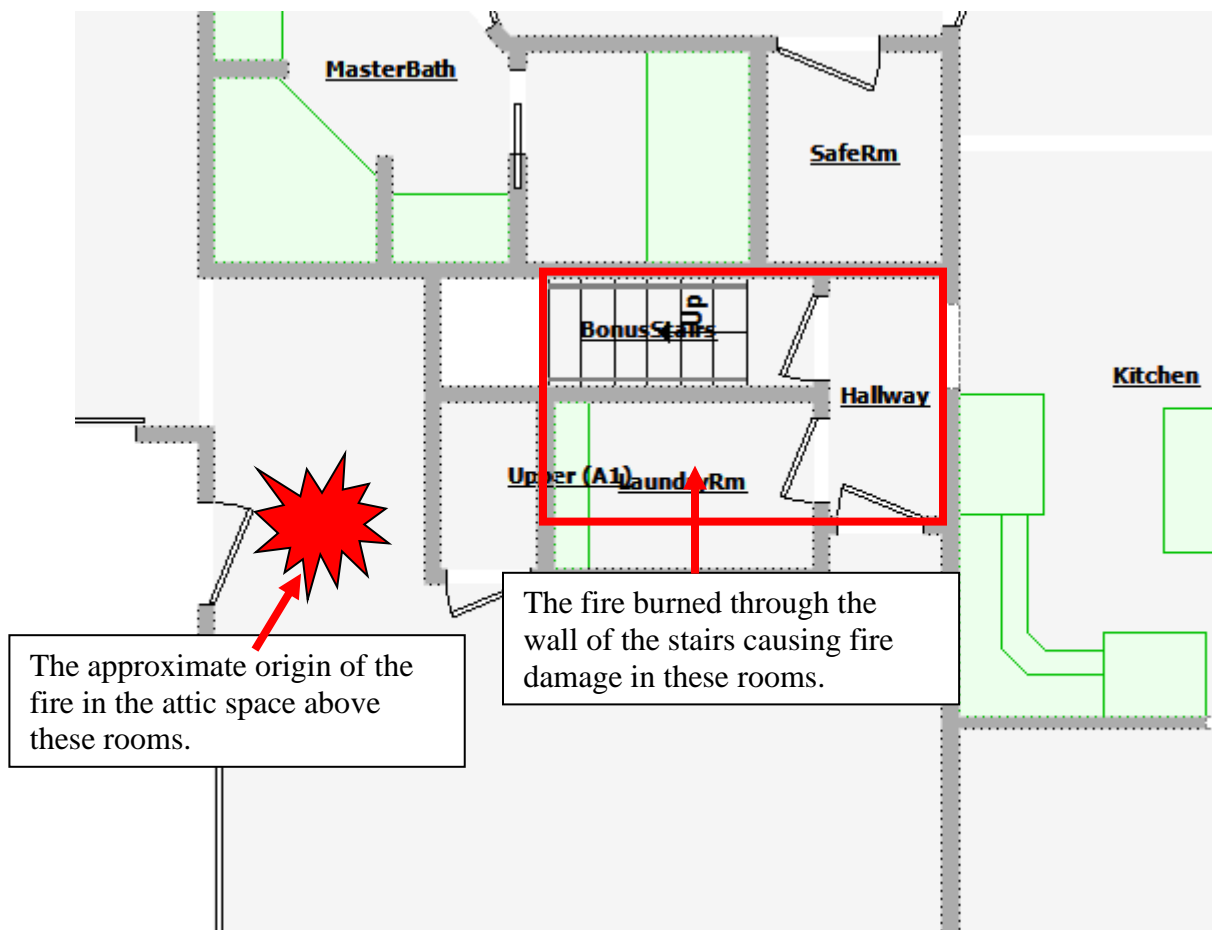
1. The fire had burned downward from the origin at the top of the stairs in the Bonus Room area. The fire damaged the finishes of the Garage Hallway and Laundry Room. Each of these rooms required the full replacement of the finishes including but not limited to: drywall, trim, cabinetry, floor tile, and light fixtures.

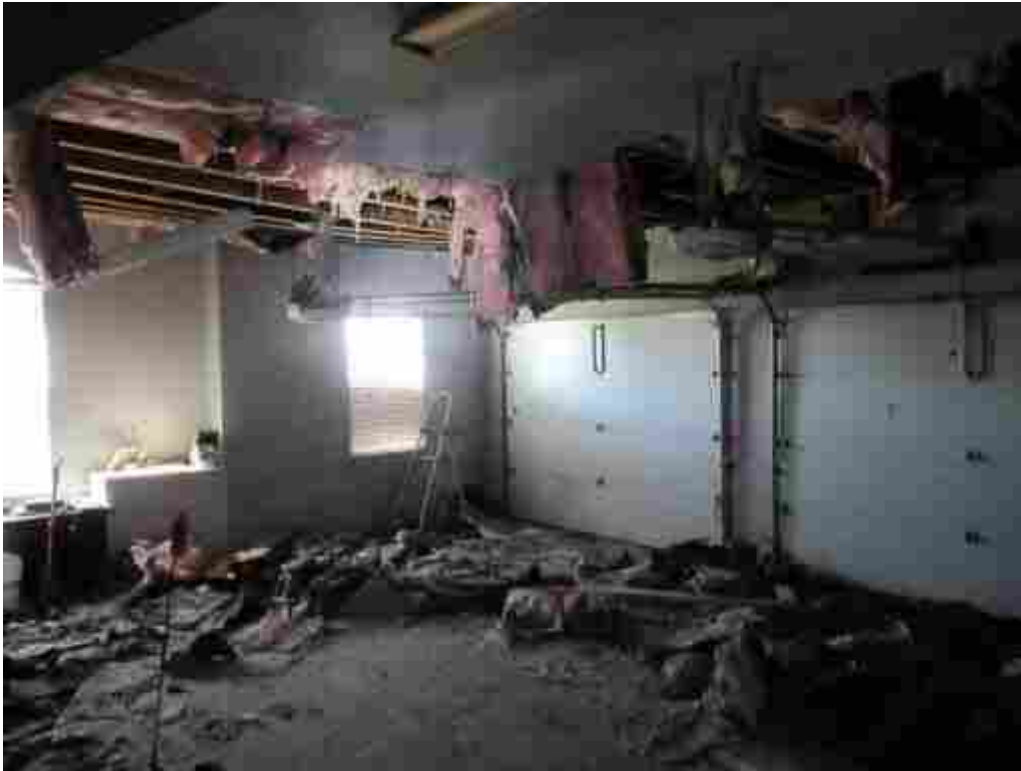
2. The ceiling of the two-car garage had been pulled down, likely by the fire department, which provided viewable access to the framing. It was found that the floor/ceiling I-beams above the garage and below Bonus Room 1 had begun to sag.

An overview of the garage looking from the entry door into the garage hall.

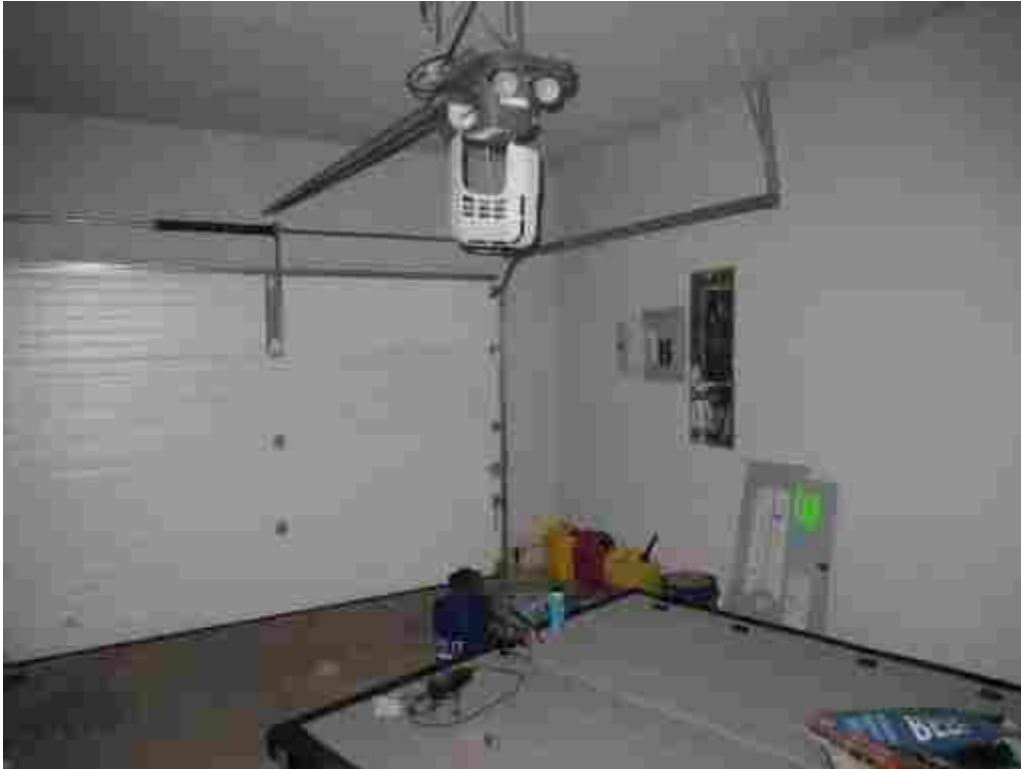
3. The finishes of the single-car garage suffered no visible fire damage. Smoke from the fire was present. However, framing above the south end of this room, in the attic space, was damaged by the fire.

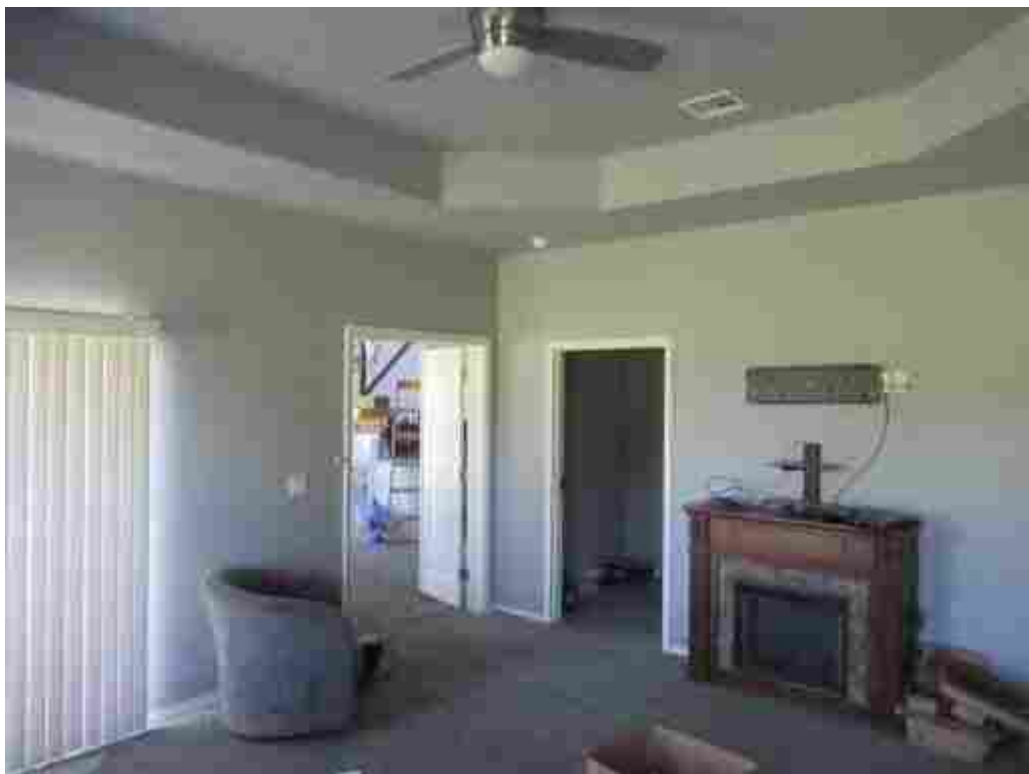
6. The remaining rooms including the Master Bedroom, Master Bathroom, Master Closets, Living Room, Powder Bath, Entry Closets, and Office all sustained soot/smoke damage. No fire damage was present. All finishes of these rooms can be remediated by cleaning and painting. The exception being the carpet and pad of the Master Bedroom and Closets. The tile floor covering ran continuously from the Garage Hallway and therefore replacement of this flooring was included in the proposed scope of work. The floor tile of the Master Bathroom and Guest Bath, as well as the white, cultured marble countertop of the Master Bathroom, were test cleaned. It was found these building components were cleanable and did not require replacement.

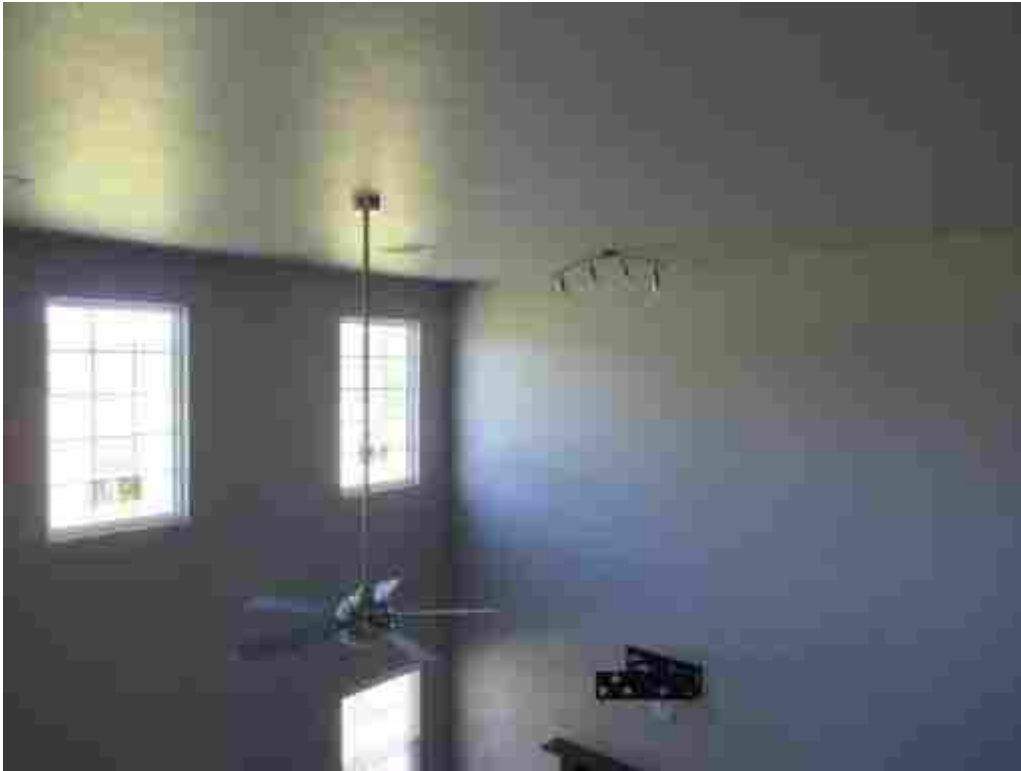
The upper sections of the Living Room.

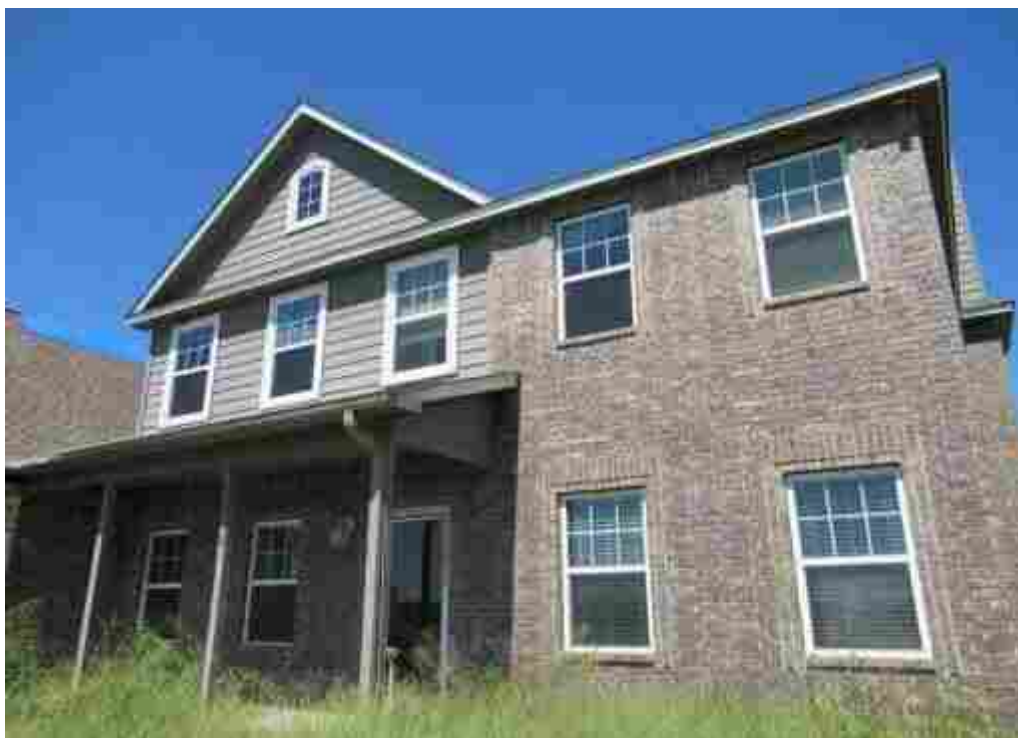
6. The east elevation of the residence was undamaged.

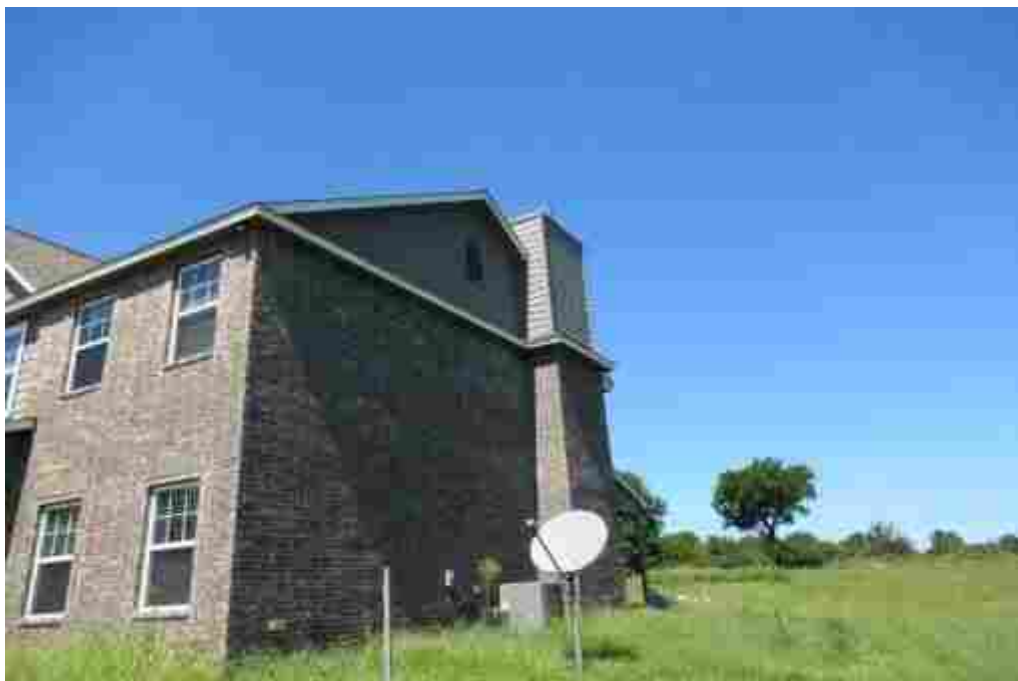
7. The back elevation was also undamaged.

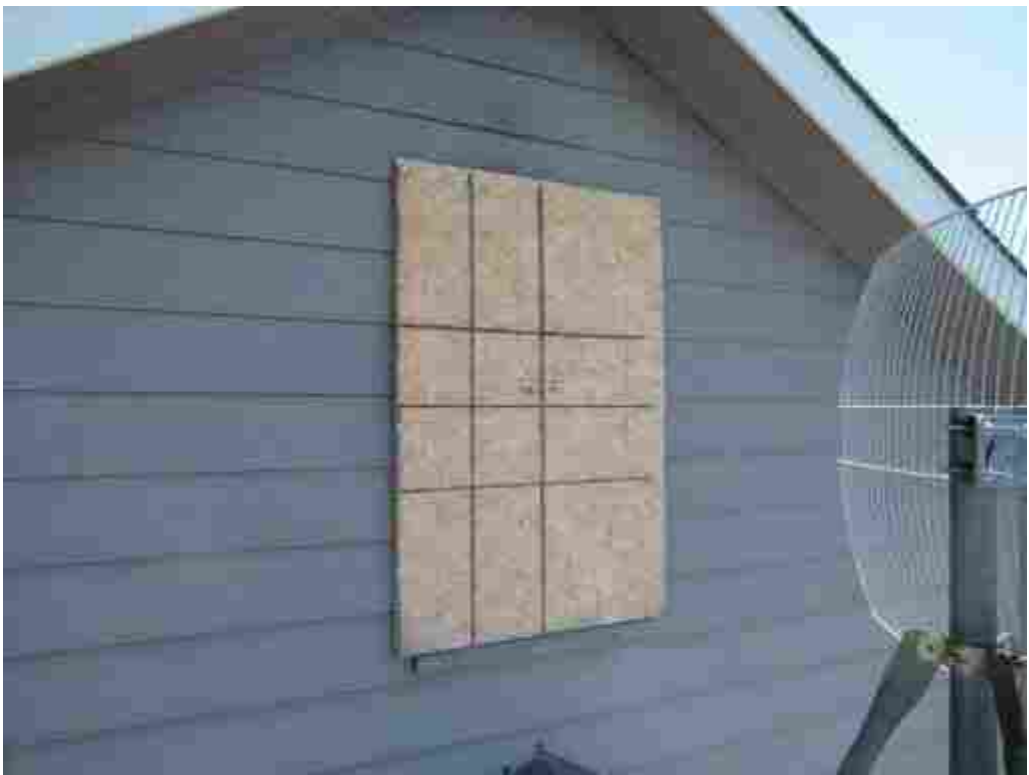
1. The shingles of the roof were found to be a 30-year laminated, composition shingle. Due to the fire damage to the framing in the Attic 1/Bonus Rooms area, much of the roof required replacement.
2. The west facing gable of the Attic 2 area exhibited smoke damage where the fire had burned through the previously discussed window.

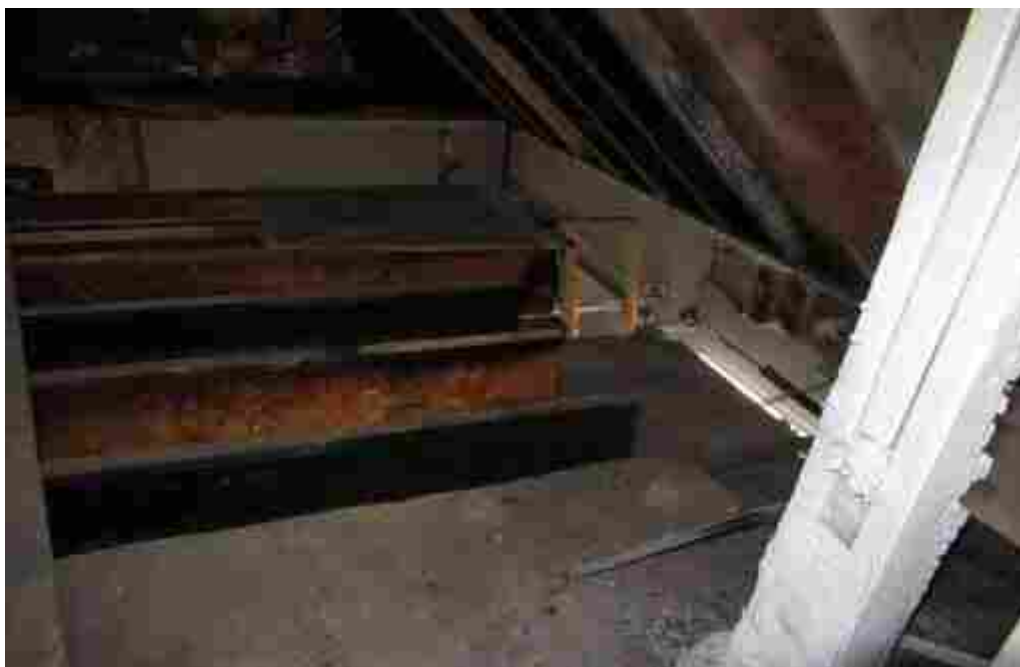
1. Much of the debris in the bonus room had been removed. The sagging floor I-beams had been cut back with a temporary wall placed below the remaining I-beams. The roof decking and some of the rafters had been replaced.

This photo is nearly the same perspective of that include at the top of page 11 of this report.

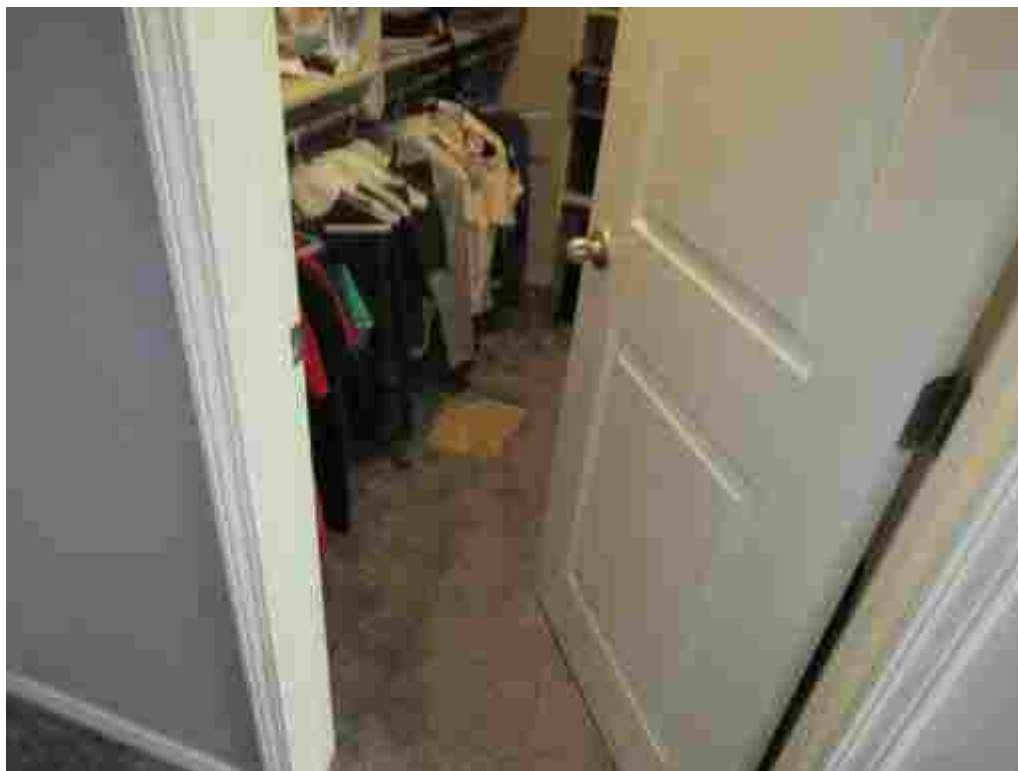
The carpeting in the closet of Bedroom 1 with the same home hole from the carpet sample extraction as seen on page 15 of this report.

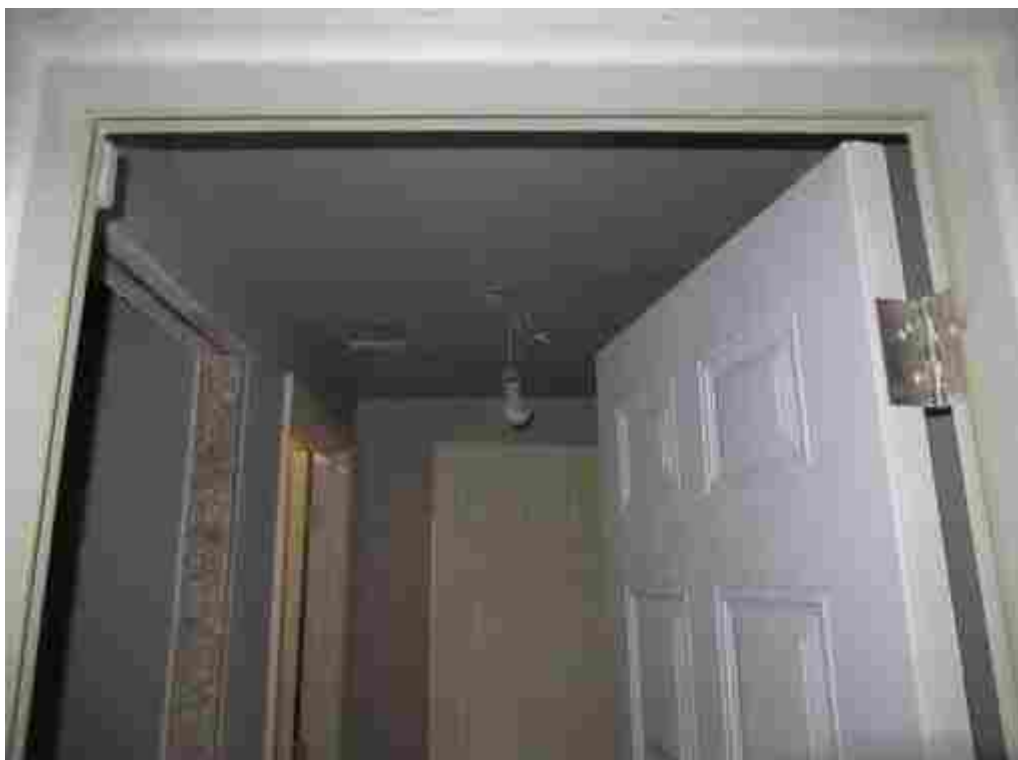
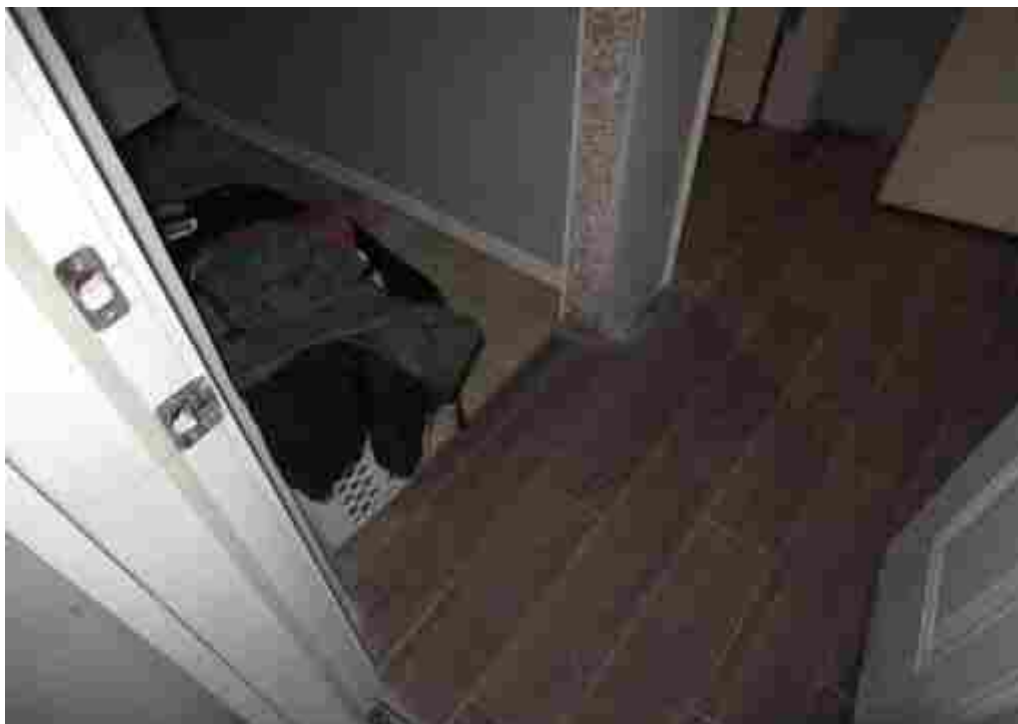
1. The fire damaged garage hallway had been partially repaired. New sheetrock, a new door to the Bonus Room Stairs, and a new door from the Garage had been installed. The room had not been painted and trim had not been installed. The flooring appeared to be the same and was not new.

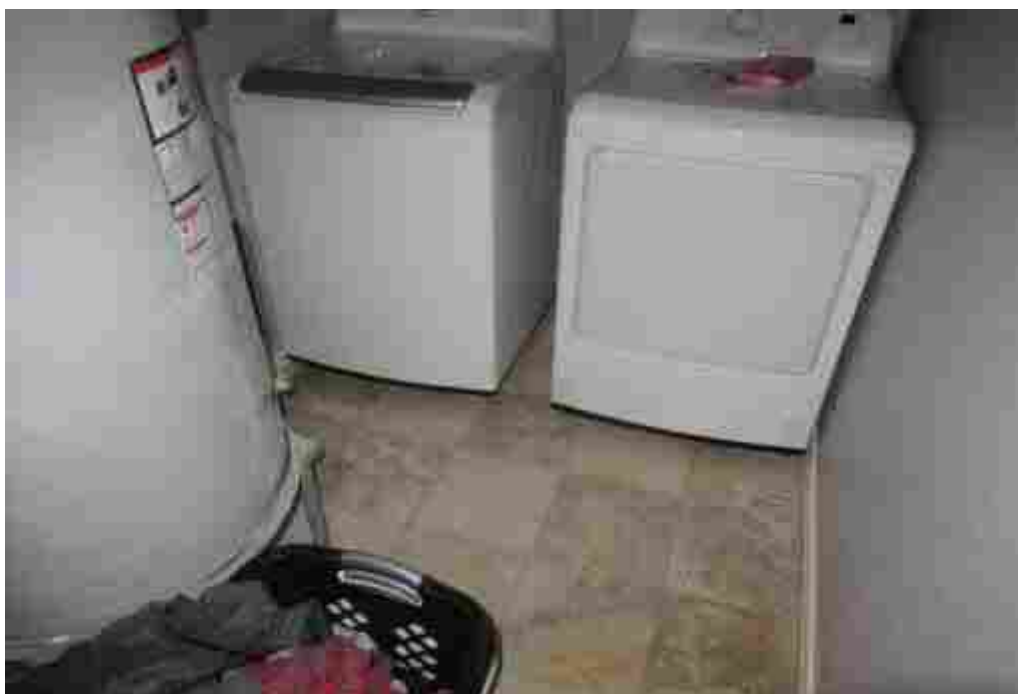
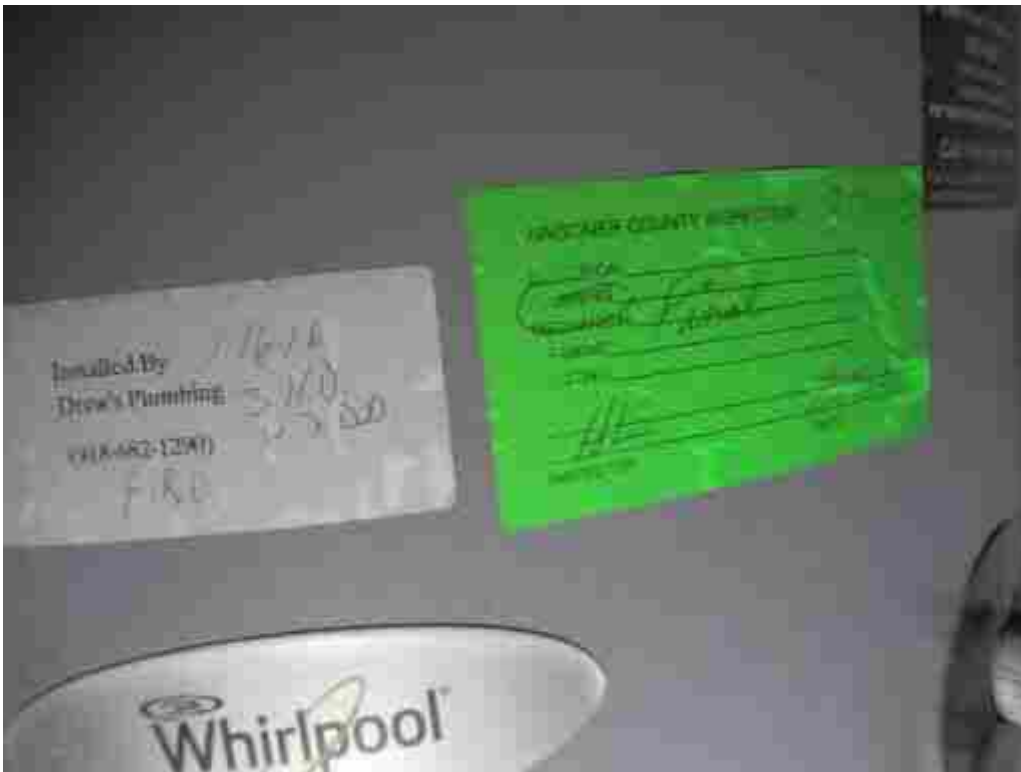
2. The Laundry Room was entirely finished indicating the finishes had not been replaced in this room. What appeared to be the original drywall, cabinets, baseboard, floor tile, and hot water heater were all still in place.

The original hot water heater located in the laundry room. The installation and inspection stickers are dated January 2016.

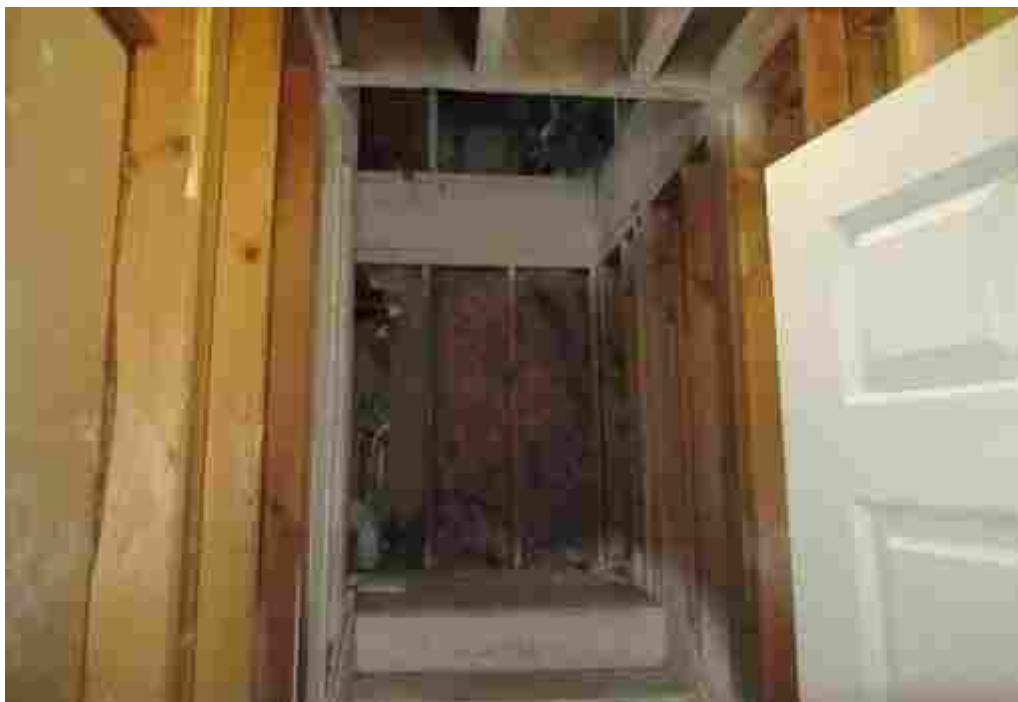
3. The stairs to the Bonus Room have largely been unrepaired except for the application of an odor control sealer.

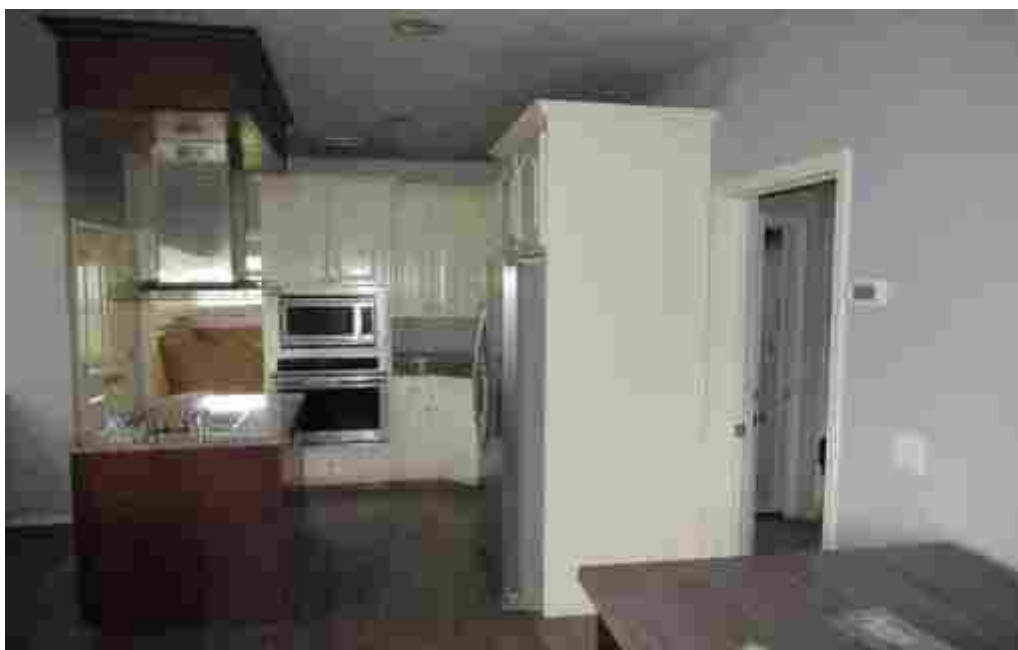
4. The fire damage to the Kitchen door casing, drywall, and cabinet bulkhead had been repaired/replaced and repainted. Kitchen fixtures had been cleaned but appeared to be the same units, including the appliances.

The kitchen from nearly the same perspective as that provided on page 20 of this report.

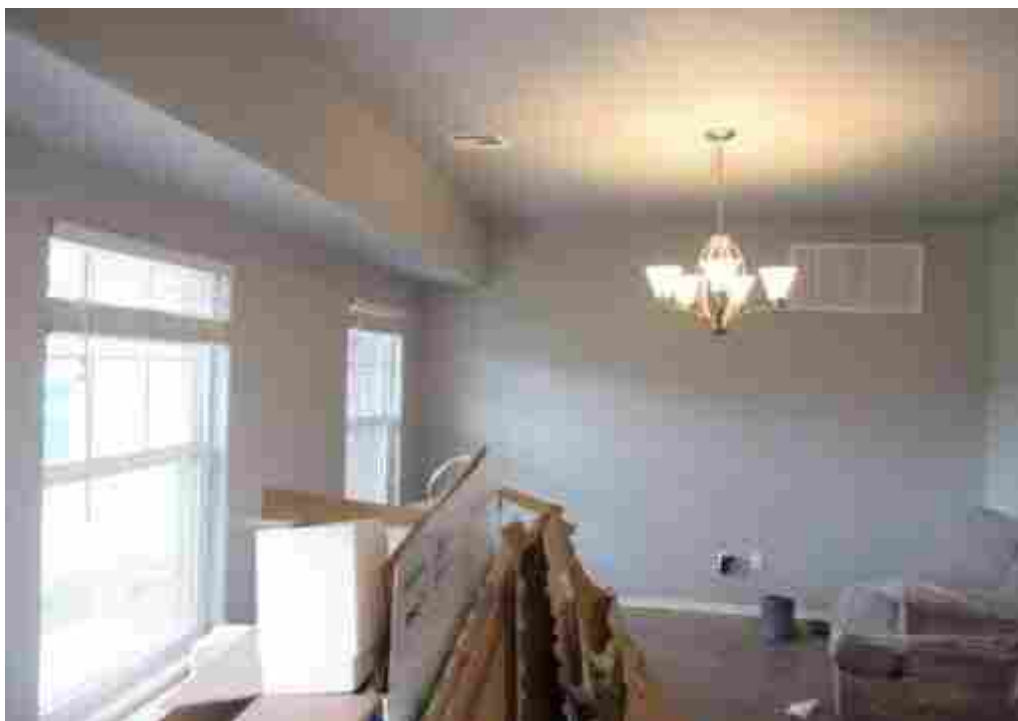
5. Drywall repairs of the holes had been made in the Dining Room and the room had been painted.

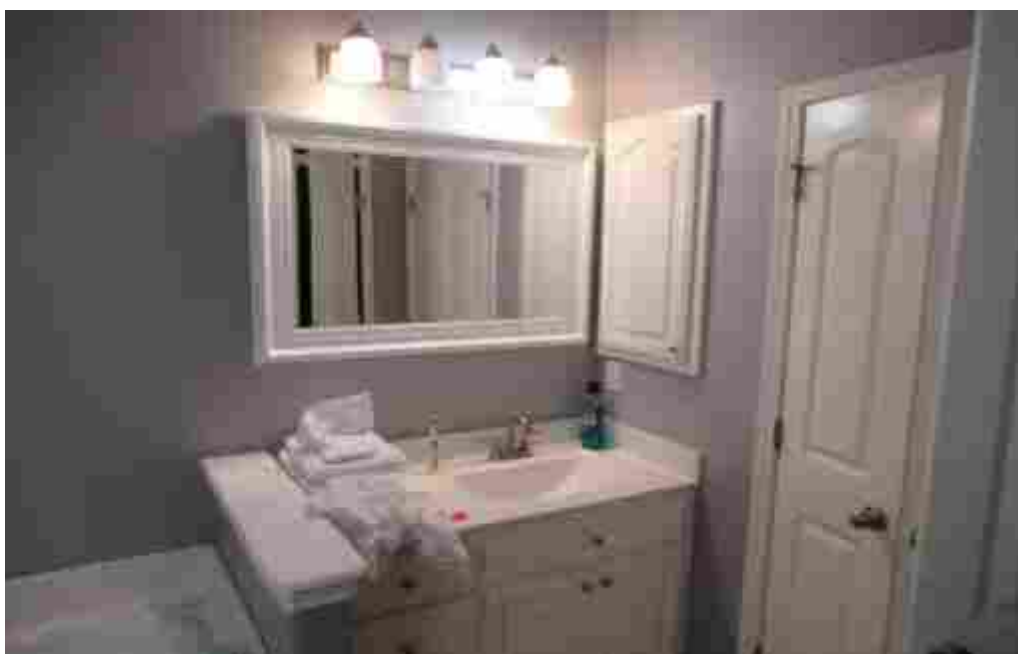
6. The remaining rooms of the Main Level had been cleaned and perhaps re-painted. All the flooring appeared to be the original flooring.

The Master Bathroom from nearly the same perspective as the photo on page 24 above.

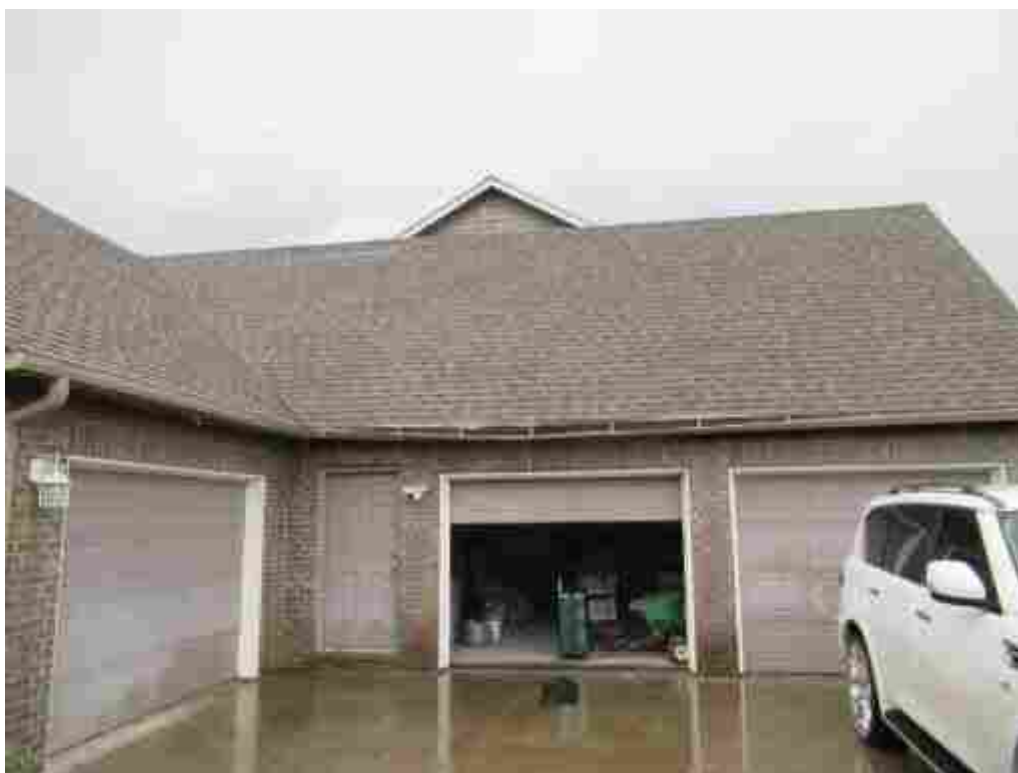
1. The roof over the two-car garage and part of the single-car garage had been replaced. The rest appeared to be original.

The section of the roof which had been re-roofed.
